NAUGATUCK RIVER BASIN
NAUGATUCK, CONNECTICUT

**THURSTON POND DAM
CT 00129**

**PHASE I INSPECTION REPORT
NATIONAL DAM INSPECTION PROGRAM**

DECEMBER 1980

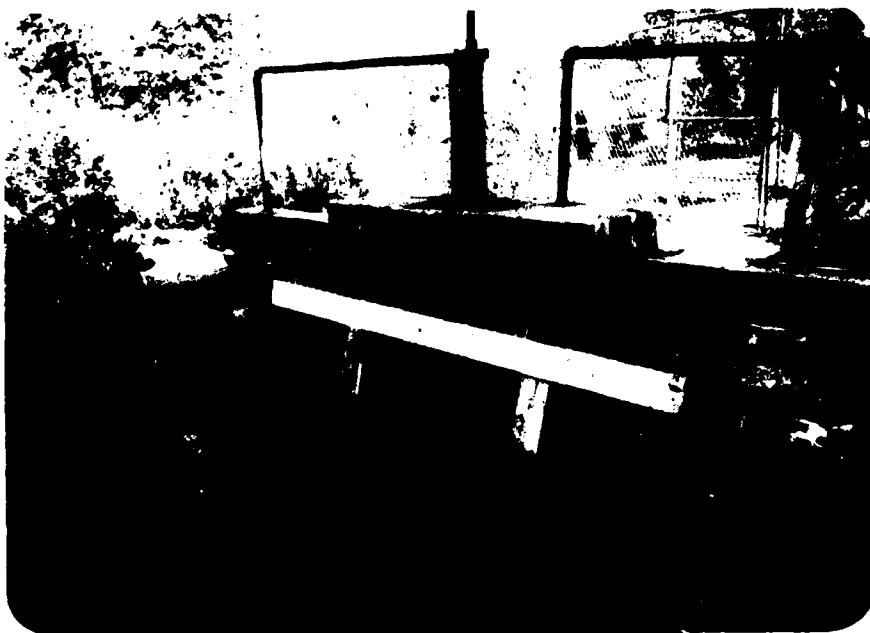
PHOTO NO. 10

The outlet works consist of a concrete intake structure located at the right abutment. The exposed part of the concrete structure appears to be in good condition, Photos 10 and 11. The intake sluice gate is in good condition and is reported to be operable. A wooden trash rack in front of the sluice gate is rotted at the water line. The intake sluice gate controls the flow into the structure and into a pipeline which supplies water to downstream locations where it is used for industrial purposes. An 18-inch concrete pipe discharges through the upper part of the right spillway training wall, Photo 9. The flow through this pipe is controlled by a sluice gate located outside the intake structure, Photo 11. The gate was reported to be operable. The intake structure and gate serve as the low level outlet for the dam. There is an overflow for the intake structure which discharges over the right spillway training wall. There are indications of erosion in front of the training wall, probably resulting from the discharge of the overflow and the 18-inch pipe.

OVERFLOW AND OUTLET
GATE AT INTAKE
STRUCTURE.

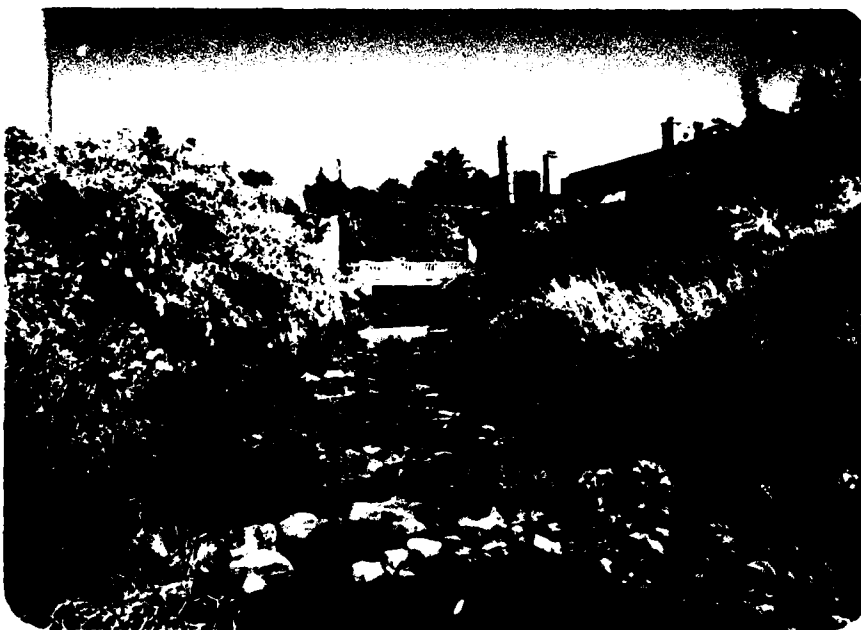
PHOTO NO. 12

DOWNSTREAM CHANNEL
